**Berryessa Creek Project**  
**Santa Clara County, California**

**Appendix D**  
**HTRW ASSESSMENT**

**HAZARDOUS, TOXIC AND RADIOACTIVE WASTE PHASE I  
ENVIRONMENTAL SITE ASSESSMENT**

**BERRYESSA CREEK FLOOD CONTROL PROJECT  
MILPITAS, CALIFORNIA**

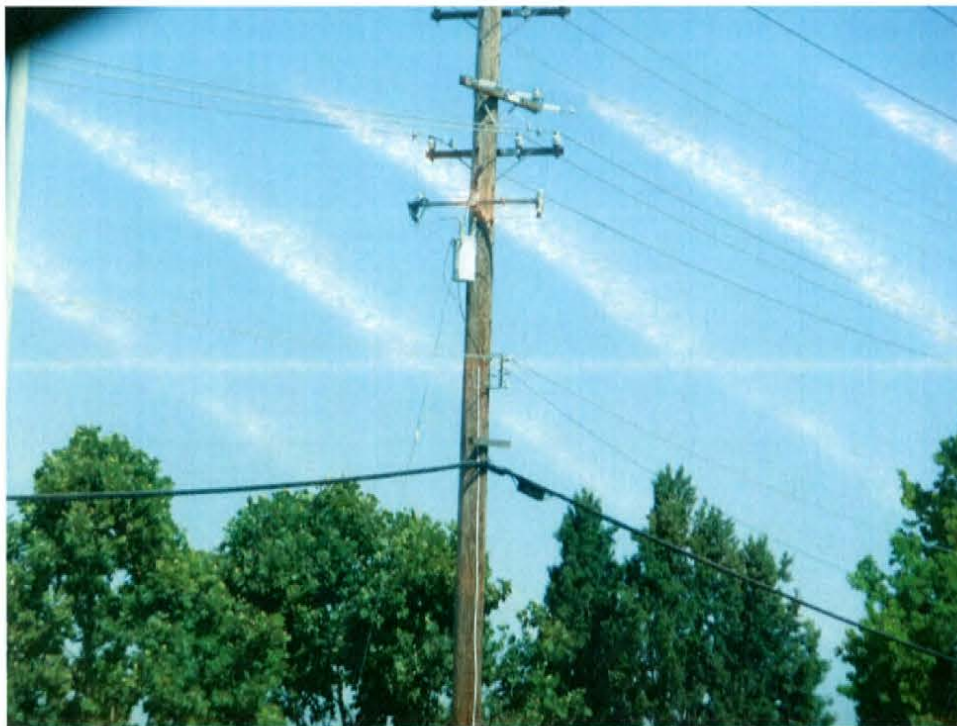
Figure 1. Tank-type transformer, pole-mounted. Blue label near bottom left of tank indicates PCB-free.

7. There are many instances of transformers in the region studied. Several examples of these are shown in figures 1-4. None of them is considered to be a REC, partly because they appear to be in good condition, secure, either by height above ground or by locked cabinets, and because they no longer contain PCBs (Ref 5).

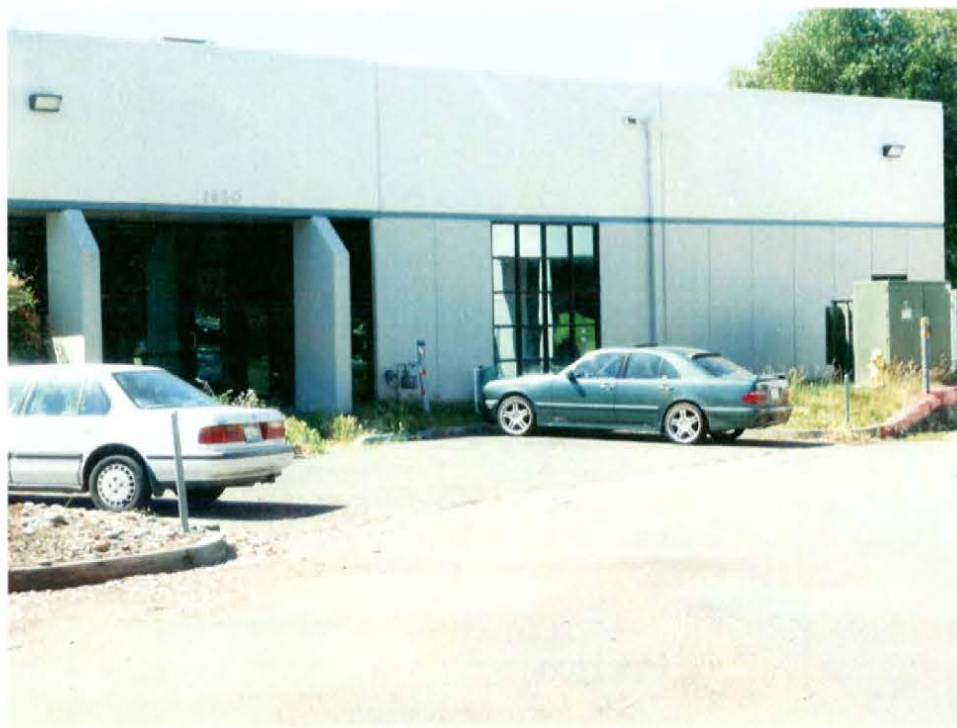
Figure 2. 1650 Watson Ct. Ground-mounted transformer to the right (typical).

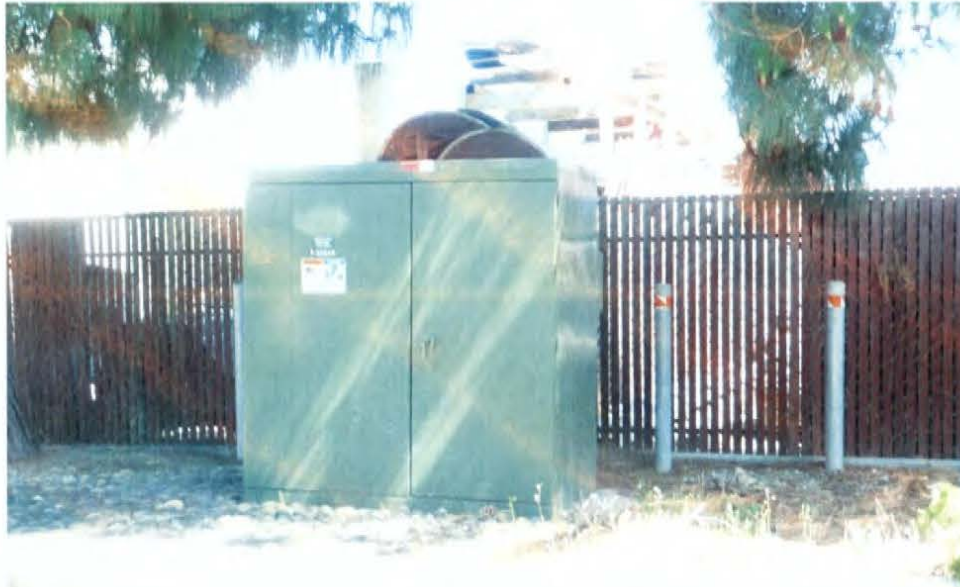
Figure 3. Ground-mounted transformer #T1142 near 1658 Watson Ct.

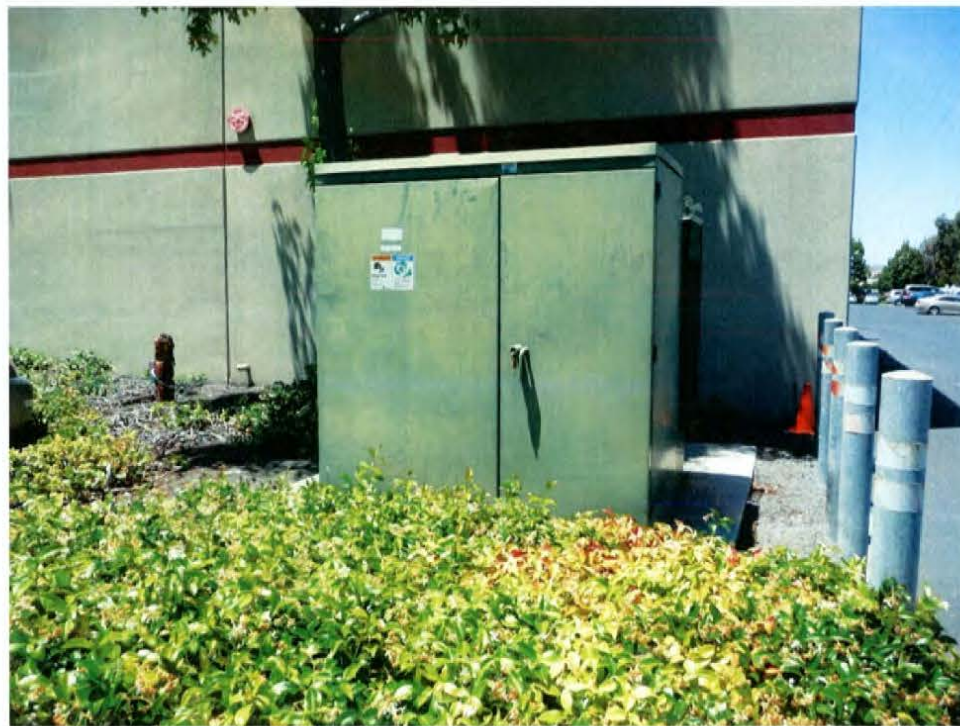
Figure 4. A ground-mounted transformer located near creek at 682 S. Hillview Dr., TDK Headway Technologies, Inc.

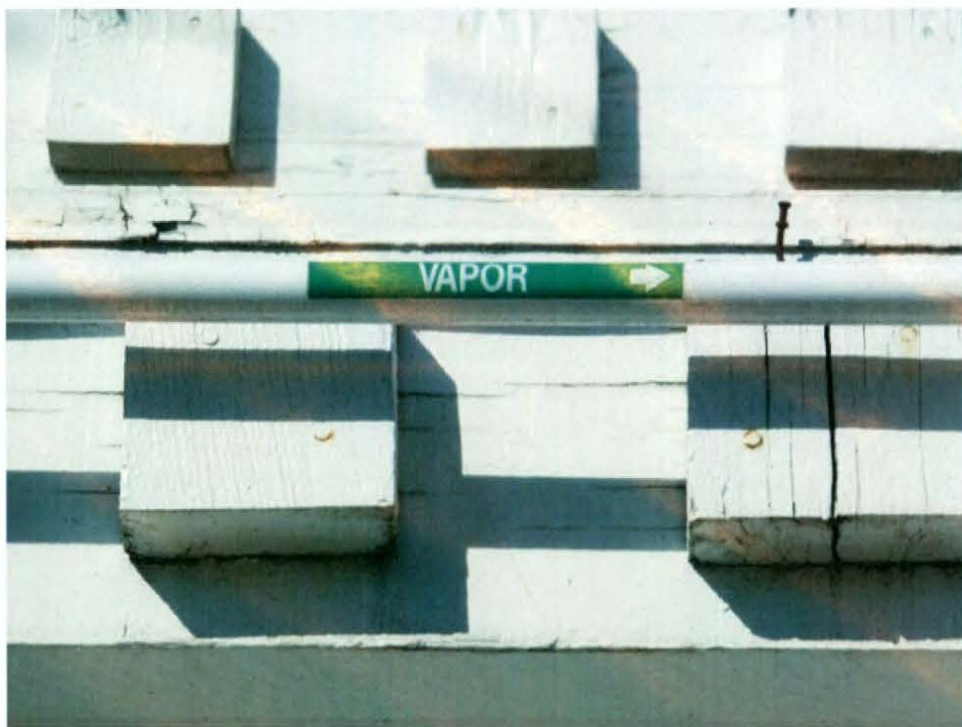
Figure 5. Return line for the fuel waste vapor tank.

1. Two gas stations (EDR #2 and # 58), which had historical releases, but the environmental sites are considered closed or no further action (NFA) is warranted (Figures 5-8 and Ref 5).

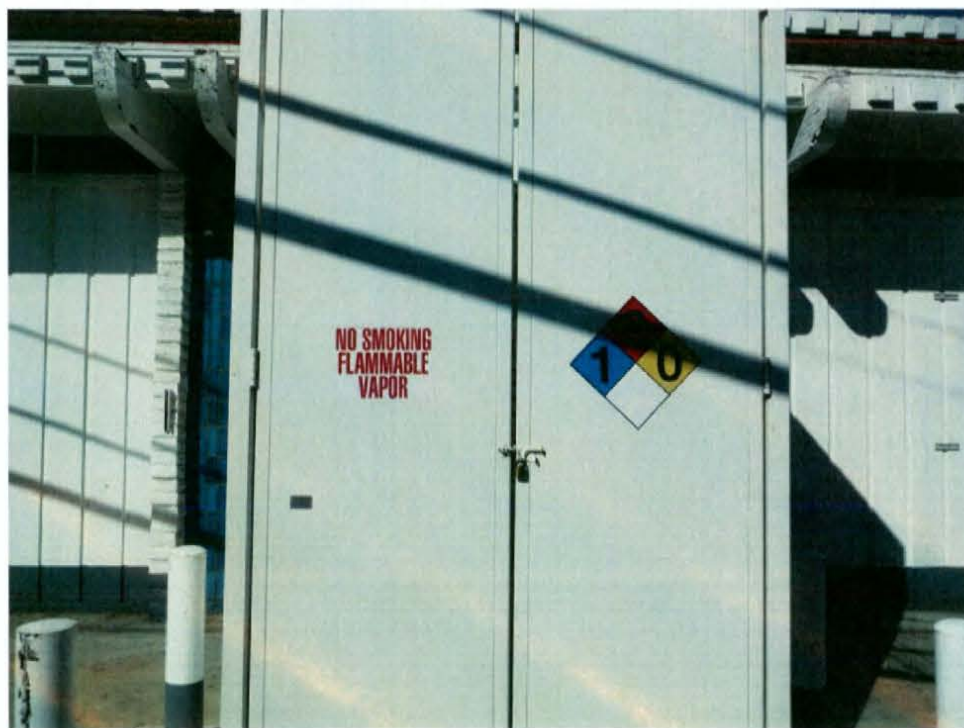
Figure 6. Waste Fuel Vapor Tank (behind secure enclosure).

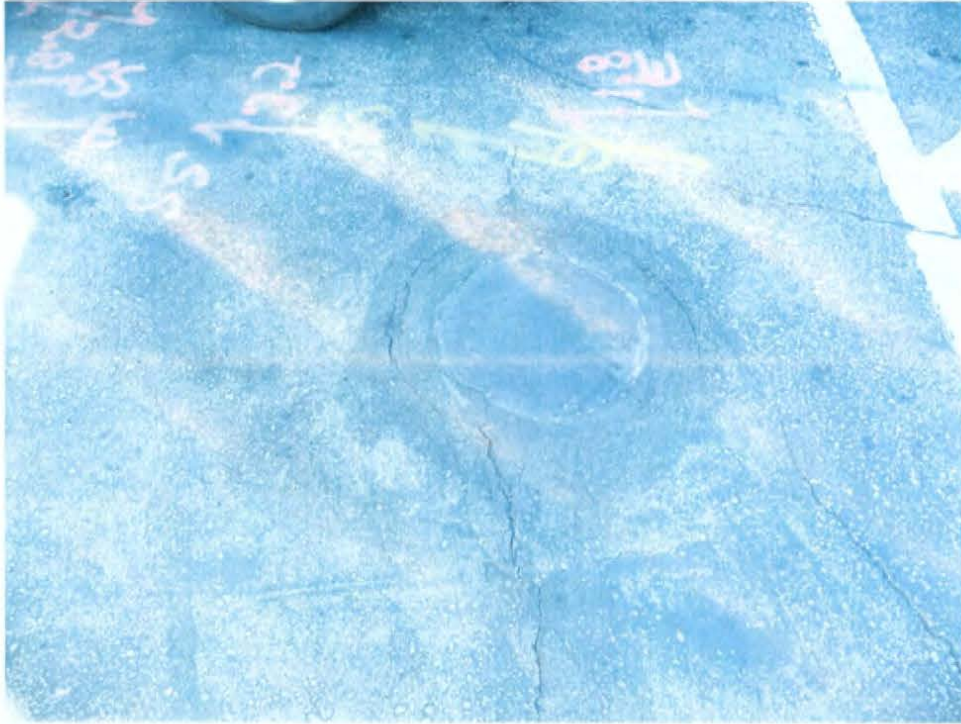
Figure 7. Repaired road surface where old UST may have been located.

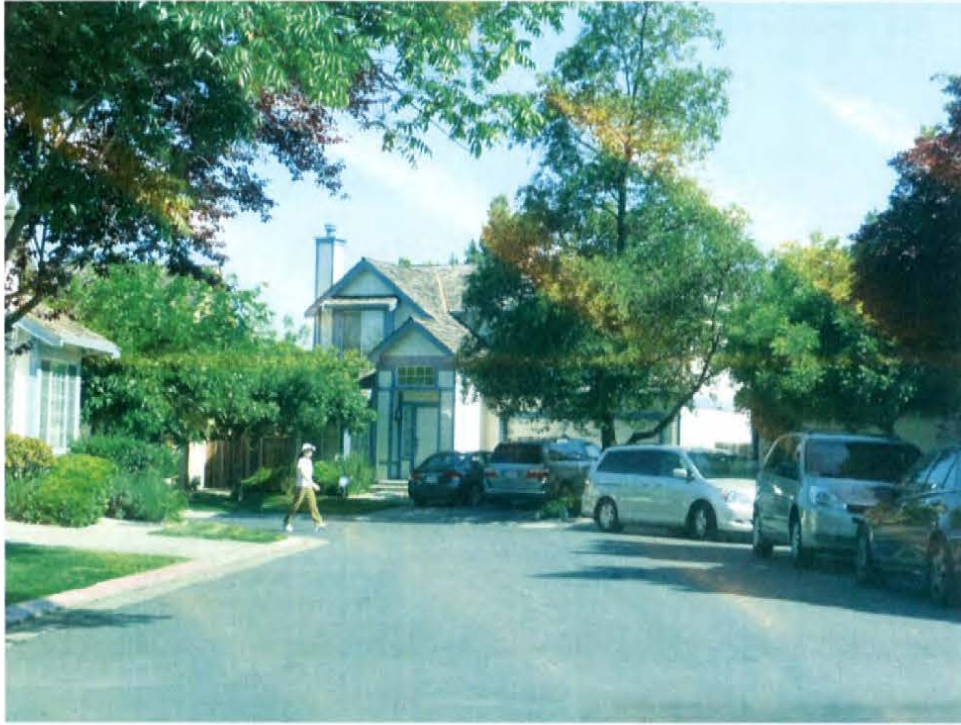
Figure 15. Stonegate residential development. No RECs apparent, however land use controls in effect.

3. One residential site (EDR #42) was reported to have a release (Ref 5), presumably during construction, but this is not currently evident (Figure 15), since the construction phase is complete and homes occupy the site. The site, located at 1260 Dempsey Rd, east of Interstate 680, is under land use controls. While this is counted as a REC, it is not considered to be close enough to affect the proposed project at Berryessa Creek.

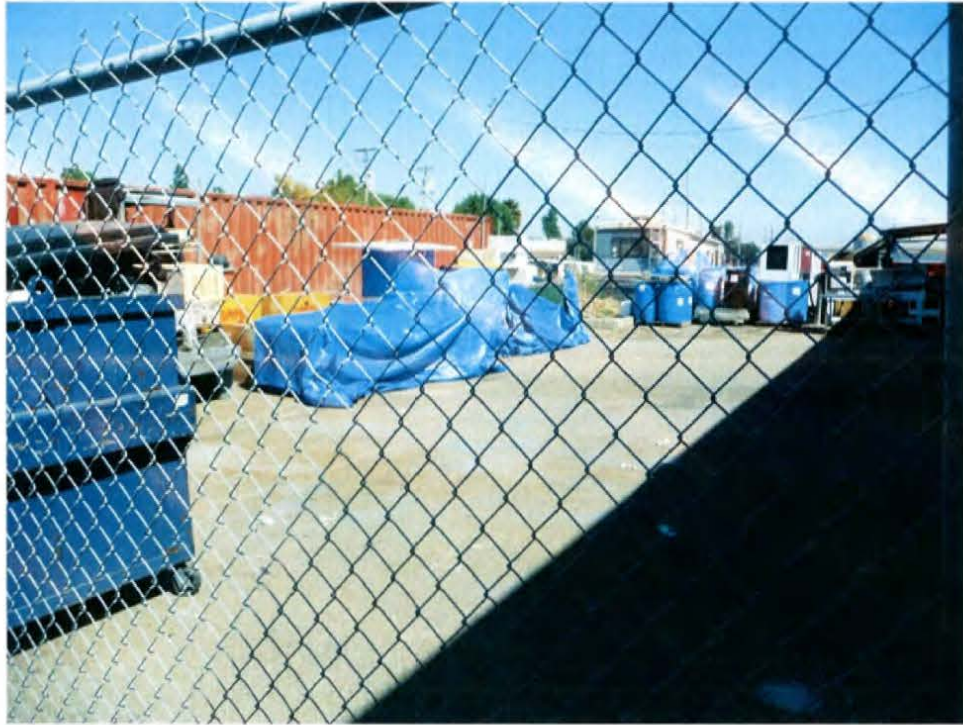
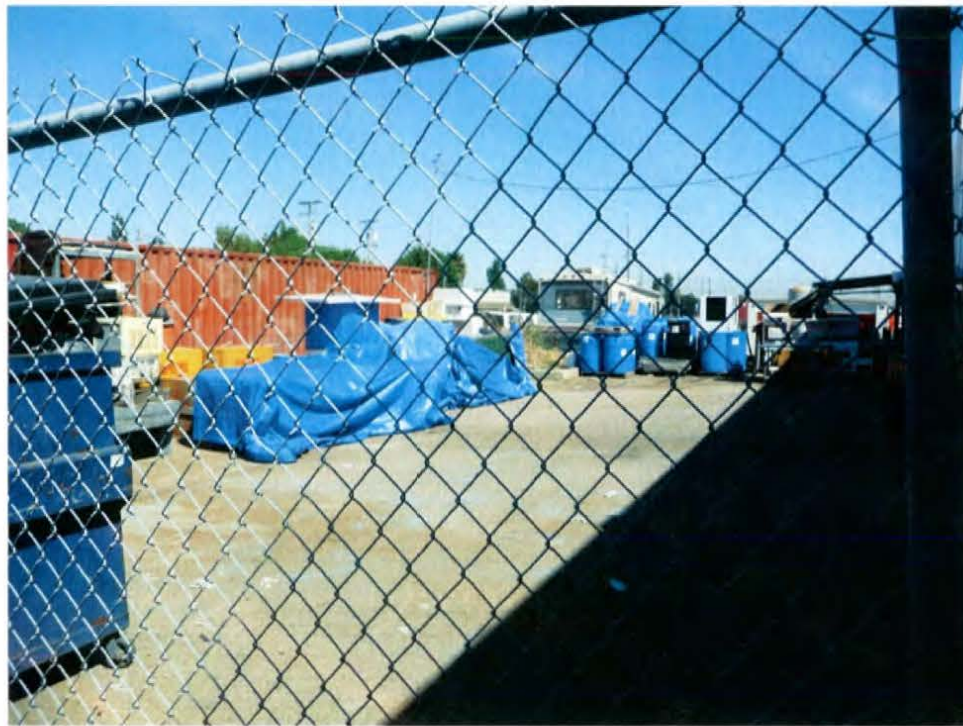
Figure 17. Flex Interconnect 1603 Watson Ct. Back of bldg. Flammables cabinets, drums marked empty. Creek is to the rear of the cabinets.

Figure 18. Flex Interconnect 1603 Watson Ct. Back of bldg. Flammables cabinets, drums marked empty. Creek is to the rear of the cabinets.

4. Three industrial sites were listed as having released a HS and are still under the same company name: Flex Interconnect (EDR #49, Figures 16-19), Vector Fabrication/KML Engineering Corp. (EDR #49, Figures 21-22), and Cordova Printed Circuits (EDR #49, Figures 23-24). These facilities were located all in the same court. Although they backed up to the creek, these facilities now are clean and exhibit no threat of a release.

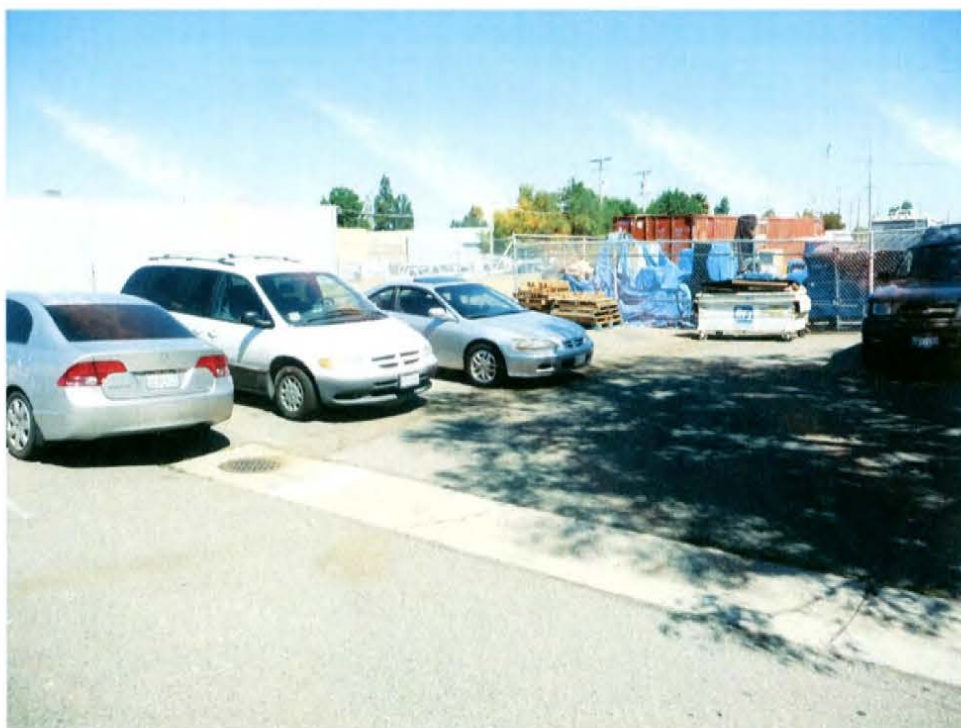
Figure 19. Flex Interconnect 1603 Watson Ct. Back of bldg. View to show location of creek, behind cars.

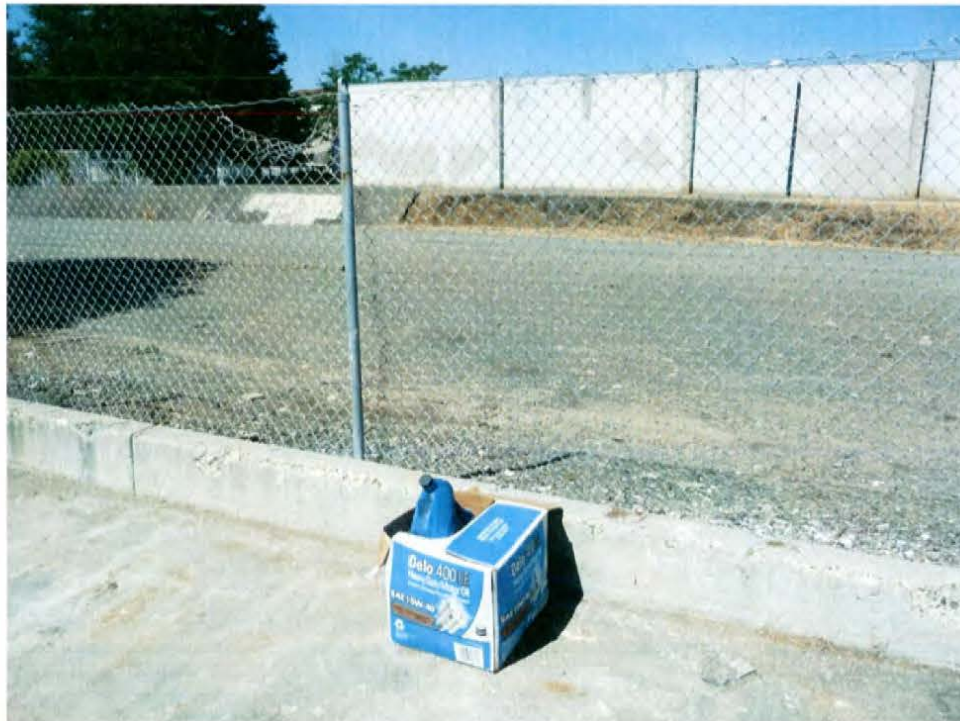
Figure 22. Waste oil cast aside near creek (in background). In lot next to Vector Fabrication.

Berryessa Creek runs through developed commercial and residential areas in Milpitas, California. The creek is generally well-maintained and free from dumping of discarded items, although the site reconnaissance team found evidence that one gallon of waste antifreeze was thrown into the creek (Figure 33) and a box of waste petroleum products was discarded on the pavement adjacent to the creek (Figure 22).

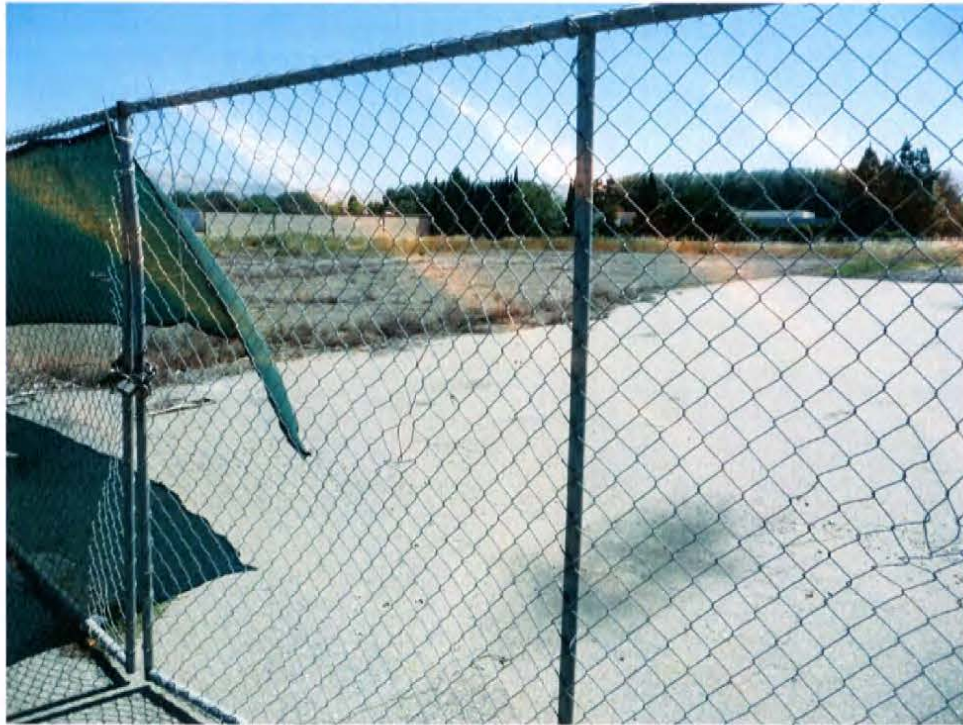
Figure 25. Kaiser Experimental Labs, 1600 S. Main St., could not be located. This is the apparent location, now an empty lot, which is fenced off. Note the distressed vegetation. #1 of 3

5. One listed site, Kaiser Experimental Labs (EDR #56), 1600 S. Main St., could not be located, but the presumed address is now a vacant lot (Figures 25-27). This site shows signs of distressed vegetation, which is a REC, but it is fairly distant from the creek, and will not likely affect construction.

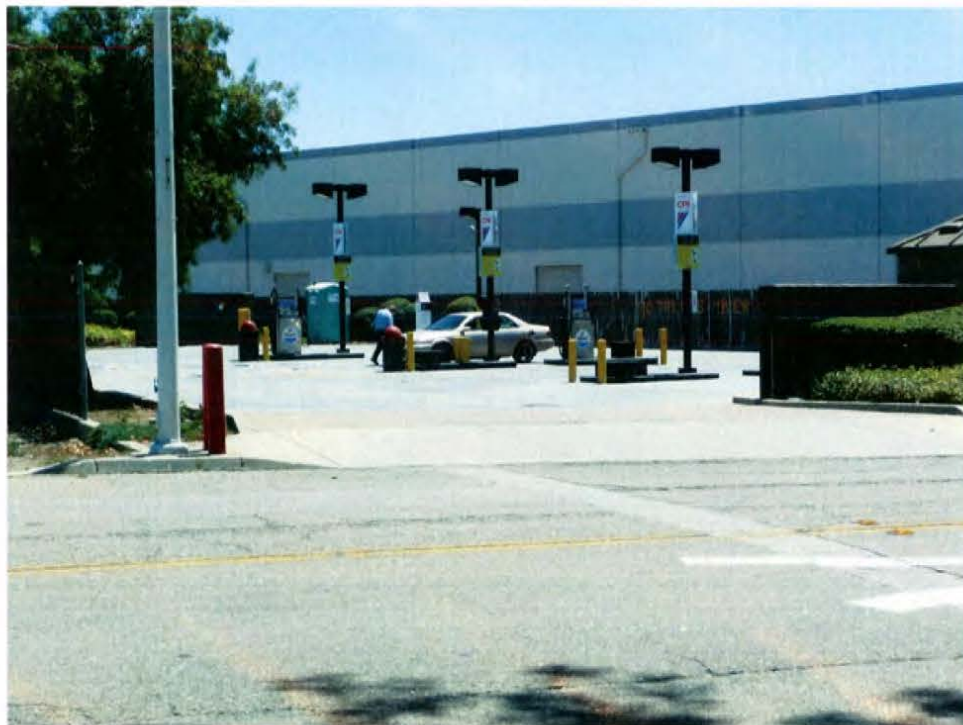
Figure 28. CFN Gas Station. USTs about 60' from creek.

6. Other sites investigated, but were not listed in the EDR Report, include a CFN Gas Station, which is located within 100 feet of the creek (Figure 28), a distribution plant, which has an AST and a UST on site (Figures 29-30), a processing plant, which has five USTs (Figures 31-32).

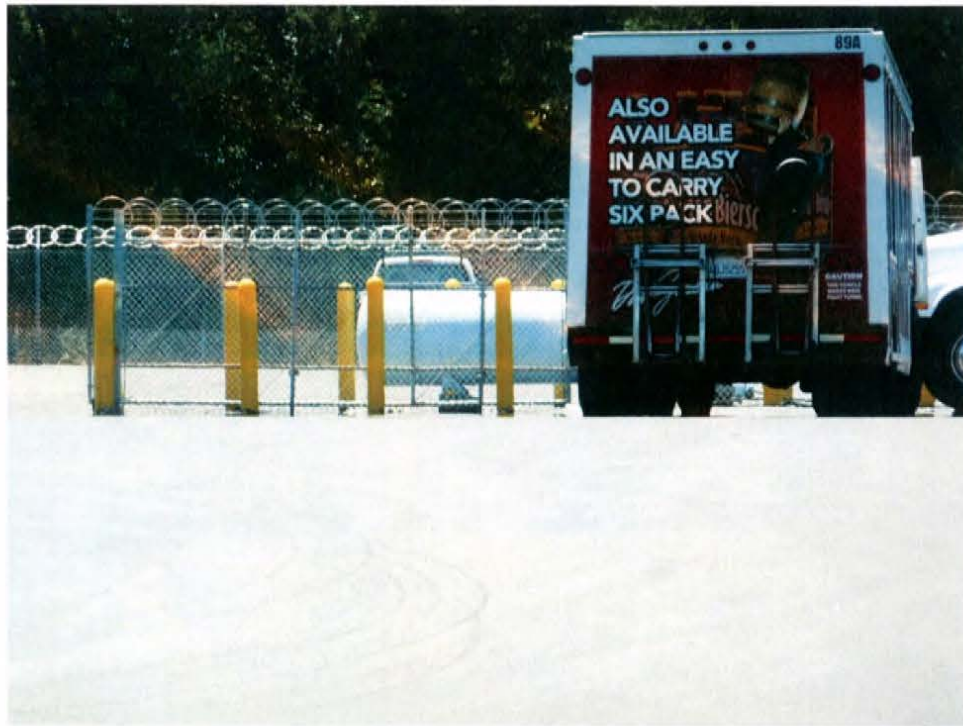
Figure 29. AST, possibly a propane tank, located about 700' from creek at Bottomley Distributing Co., 755 Yosemite Dr.

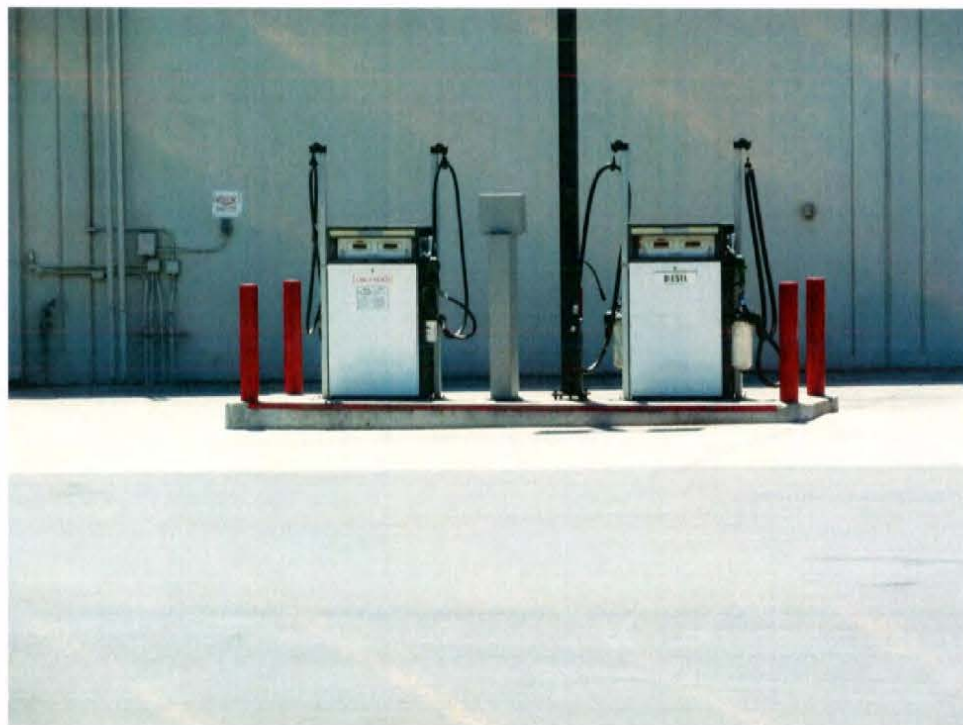
Figure 30. UST, located about 500' from creek at Bottomley Distributing Co., 755 Yosemite Dr.

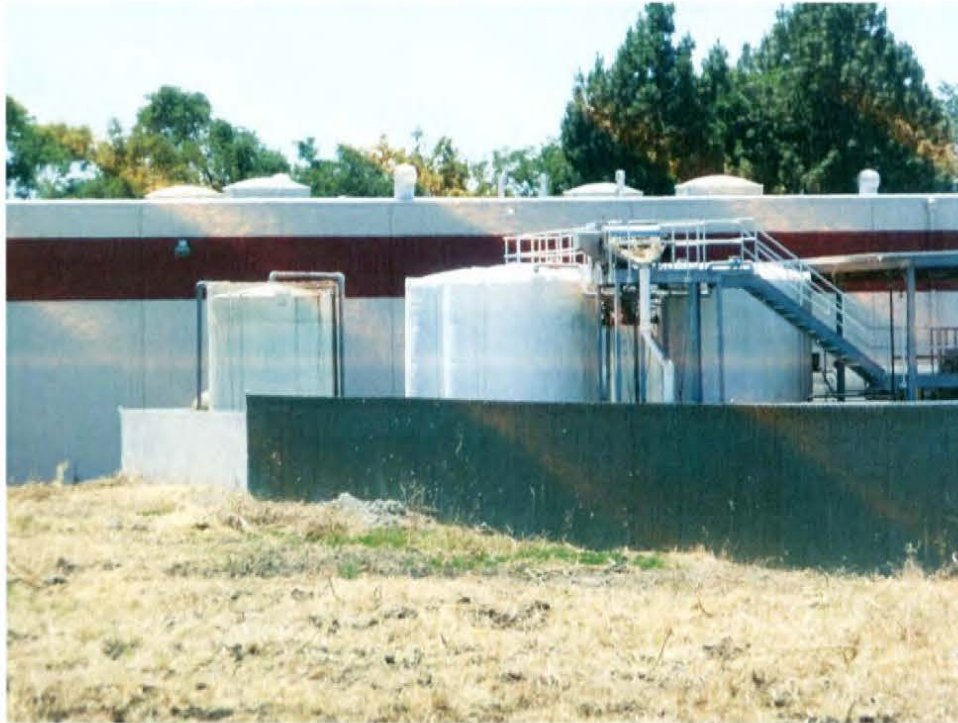
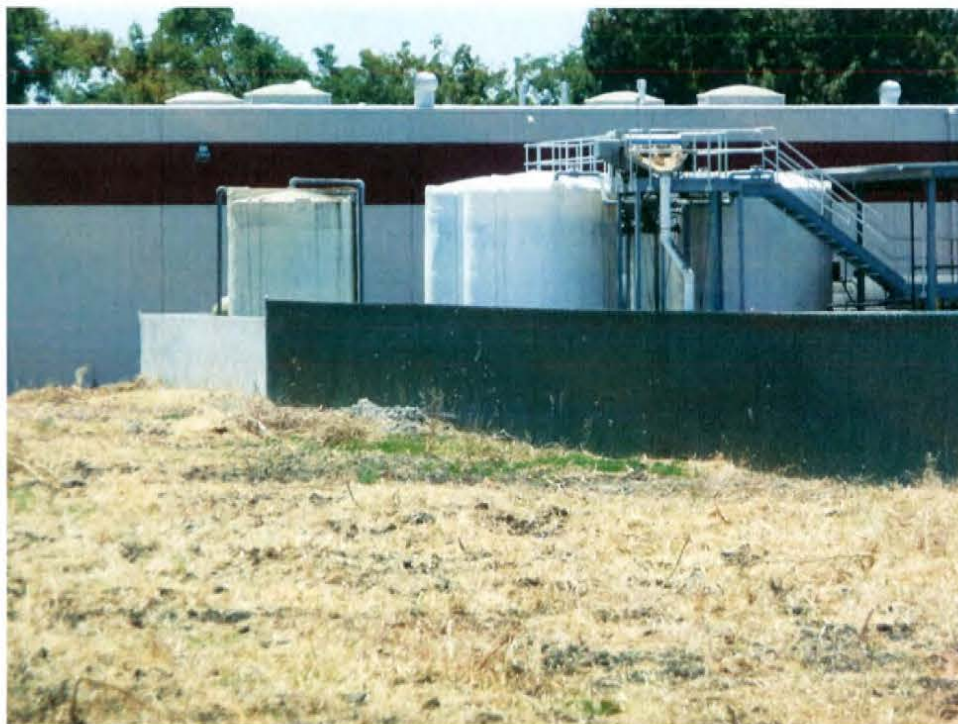
Figure 31. Five white plastic ASTs, located about 500' from creek, containing unknown liquid. Tanks are in operation and are secured behind fence.

Figure 32. Five white plastic ASTs, located about 200' from creek, containing unknown liquid. Tanks are in operation and are secured behind fence. (Second view)

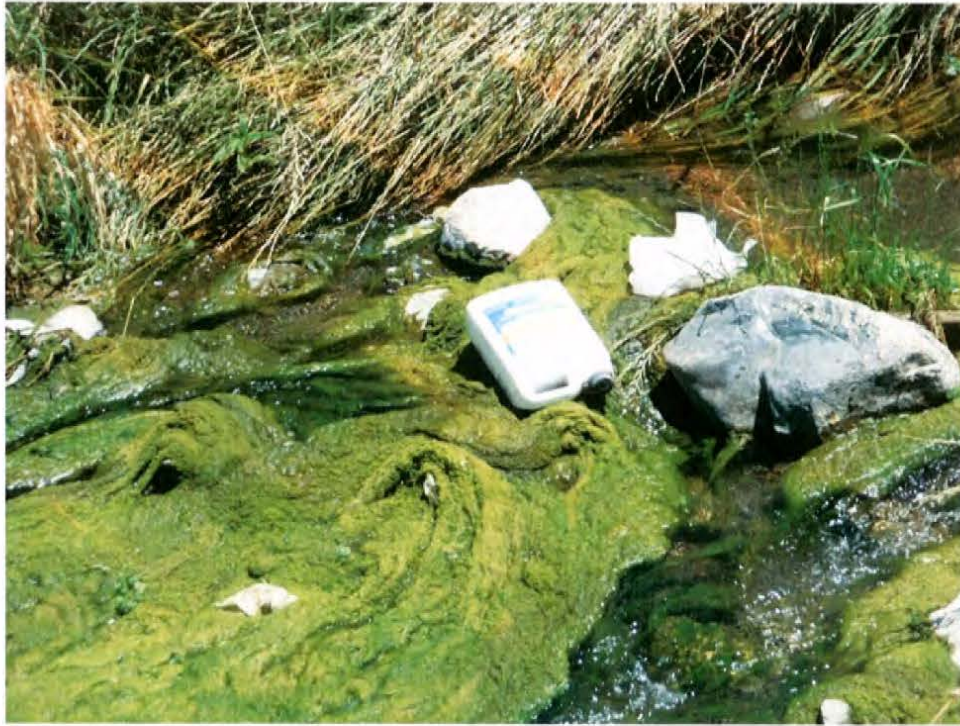
Figure 33. A rare instance of HW discarded into the creek. In this case, one gallon of antifreeze.

8. The final segment of the reconnaissance involved walking along the creek. The creek and the immediate surroundings appear to be routinely maintained, since only two instances of discarded materials could be found (Figure 33). The 1-gallon container of antifreeze is not considered to be a REC due to its small size, and it was empty or nearly empty. There are a few bridges and a few power transmission lines that cross the creek (Figures 34-37). The properties that are immediately adjacent to the creek consist mostly of commercial structures, but there are also a few residential neighborhoods in the
